Aidan Tuckett B.Sc.(Hons).

MARINE SURVEYOR

REPORT OF AN INSURANCE SURVEY CARRIED OUT ON THE VESSEL:

██████████ 1982 wooden sloop

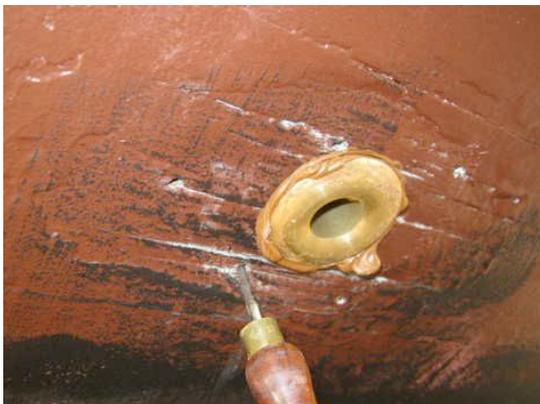
The planking around the engine seawater intake (which has been replaced) is cracked and has deep unfilled screw holes (shown) - presumably from where a grid was attached. This has since been overprimed and antifouled. **It would be advisable to fill these cracks and screw holes when the vessel is**

next ashore and to build up a greater thickness of primer to prevent local deterioration of the timber (B).

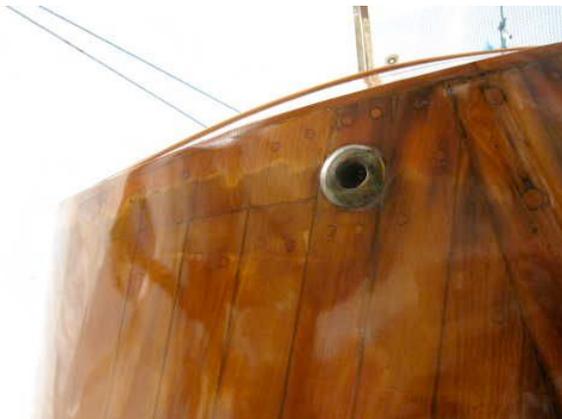
There is a small area of short lengths at the edge of the port transom (shown); these appear to be a local surface repair and are secure.

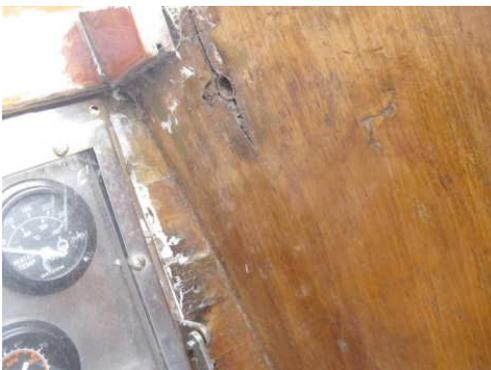
The plywood is decayed around the aft engine control panel (shown).

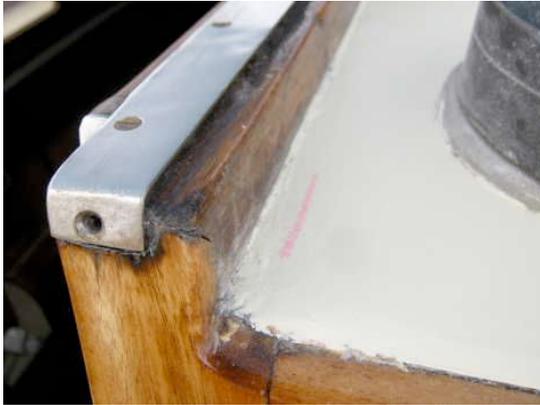
There is a hollow area beneath the sheathed plywood to starboard of the main companionway (shown in red chalk) which is likely to have soft plywood beneath. If it spreads or leaks it should be cut out and filled to prevent further damage.

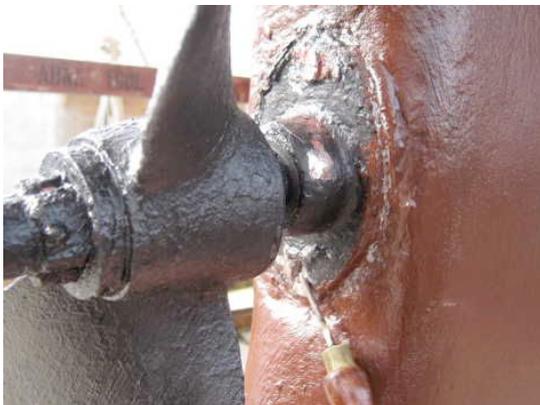
The cutlass bearing is secured to the deadwood with two screws, the heads of which are damaged/ partially missing (shown). The bearing will not come off (it will be threaded onto

a bronze tube), but it would be advisable to replace these screws when the vessel is next ashore (B).

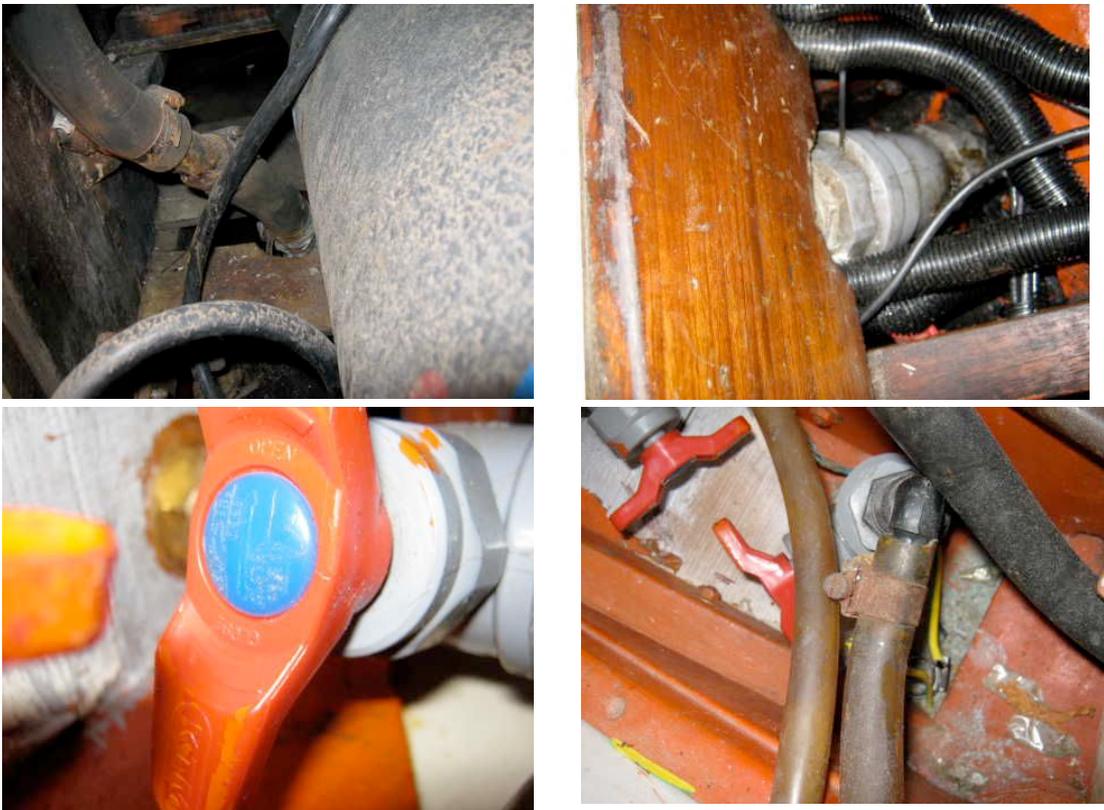
All of the through hull fittings apart from the engine water intake are nylon, marked 'KTM' (shown bottom left). The only nylon skin fittings that have type approval in the EU are made by 'Marelon'. Non metallic skin fittings are increasingly vulnerable to damage as all plastics of this type become brittle with age. It would be advisable to replace them with new DZR ball valves which are relatively inexpensive and should thread straight onto the existing bronze through hull fittings (B). These should be thoroughly inspected when the plastic seacocks have been removed. Note the cockpit drains share the engine space so even a minor engine fire will quickly render them inoperable.

- A. Bilge pump drain access forward under sink in heads, **hose clip corroded (see bottom left picture). There should be two clips.** Nylon valve.
- B. Sink drain, access forward under sink in heads. Nylon valve.

- E. Port cockpit drain, access limited beneath calorifier (top right photo), nylon valve.
- F. Starboard cockpit drain, inaccessible and not properly inspected. A metal 'Y' section joins the sink drain to this above the fitting **and is corroded** (top left photo).

the cockpit drain skin fittings and the stern gland. In particular it was found impossible to access the starboard cockpit drain handle and the port one could only be worked with difficulty. **It is recommended that access holes be cut in partitions/ shelves to allow quick access to both these valves (A).**

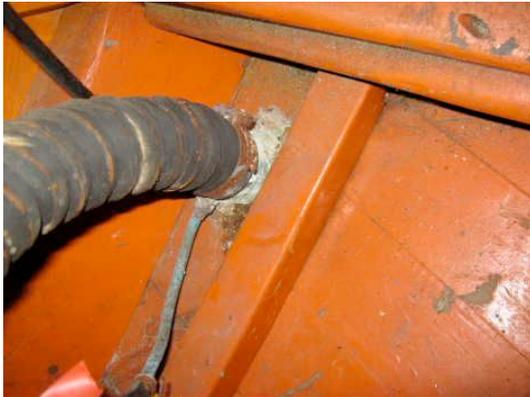
One of the two above waterline skin fittings at the transom (the pump outlet) **has a corroded hose clip (shown) which should be replaced (B).**

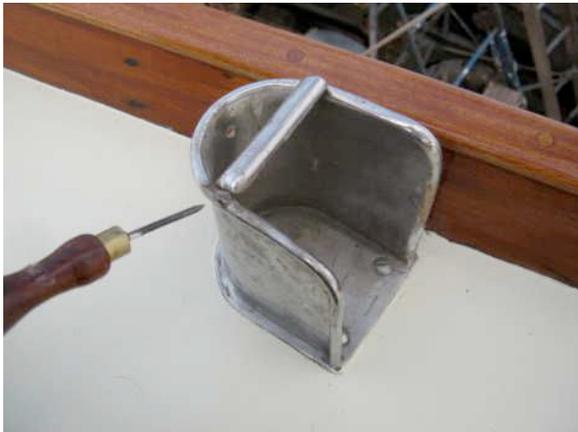
A bracket to hold the base of the spinnaker pole is broken (shown). It should be possible to weld this back.

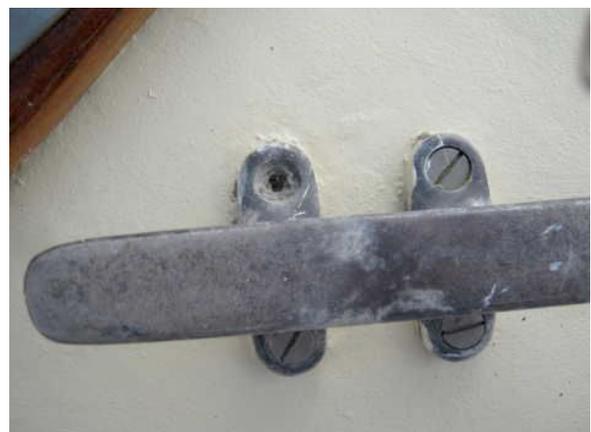
One of the cleats at the base of the mast is missing a bolt (shown).

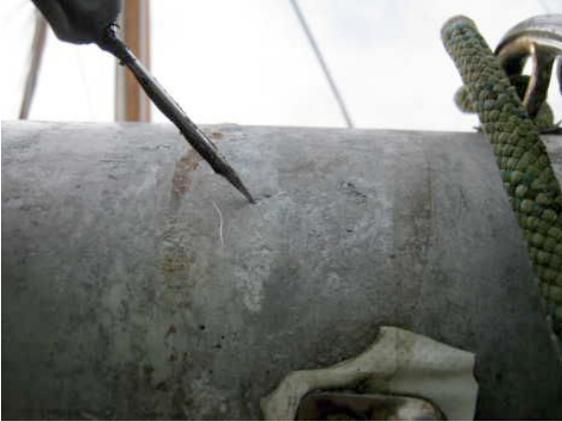
The aluminium is slightly pitted where the mast boot covers it (shown). None of the pits are deep but it is recommended this be coated with Vaseline or Blakes 'Mast protect' when it is refitted.

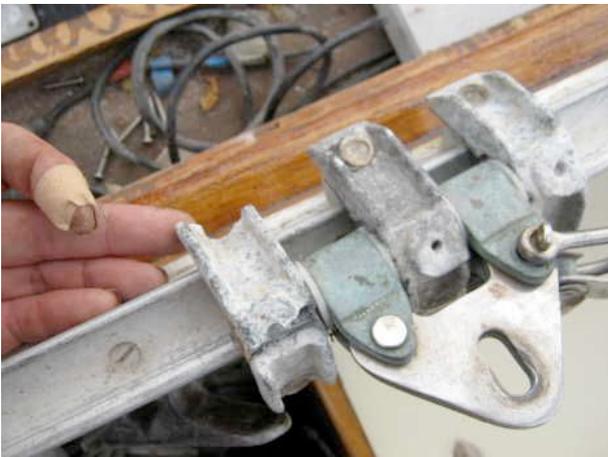
The mainsheet traveler has a broken roller (shown) and may give in an accidental gybe. **It should be replaced (B).**

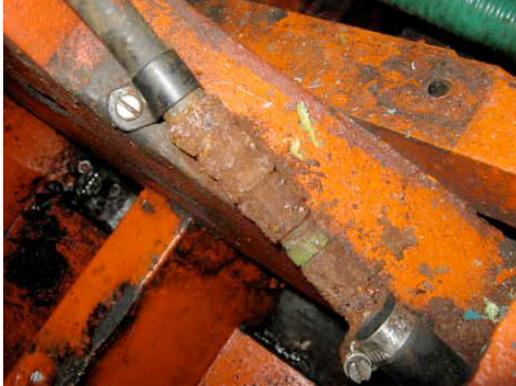
The fuel hose is black rubber, un-marked but in good condition. A connector within the engine space is heavily corroded (shown) although not leaking. It is suggested this be replaced along with the hose, the latter using fire resistant type conforming to BS EN ISO7840 when the system is next refurbished (B).

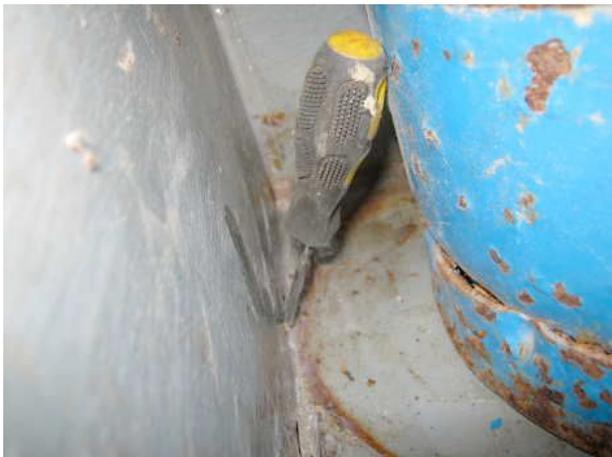
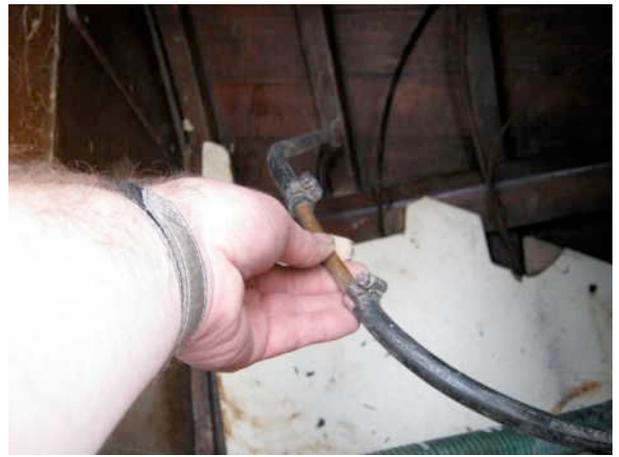
There are two 3kg gas bottles in a plywood locker in the cockpit. This has holes through to the bilge along its corner joints (above left). There is a drain to the cockpit at the front but as the cockpit drains exit beneath the waterline this would only allow any leak to disperse slowly. It would be possible to laminate fibreglass within the locker to at least prevent leaks escaping direct to the bilge, but note present day standards require gas lockers to drain directly overboard.

The rubber gas pipe appears original (marked with Spanish text) and runs from the bottle with a short connecting piece of copper pipe (shown) then to the cooker in a continuous length. Again this would not comply; flexible hose should be no more than 1m long from the bottle to a fixed pipe which should be secured every 200mm, then an armoured flexible section from the bottle to the cooker. Connectors should be purpose made. The hose should be no more than 10 years old. There is no gas tap next to the cooker. There is a three burner gas cooker with no flame cut offs incase one of the burners extinguishes - all are requirements.

The gas system as presently installed is unsafe and should be replaced (A).
