MARINE SURVEYOR

REPORT OF A CONDITION SURVEY CARRIED OUT ON THE VESSEL:

“ [REDACTED] ”

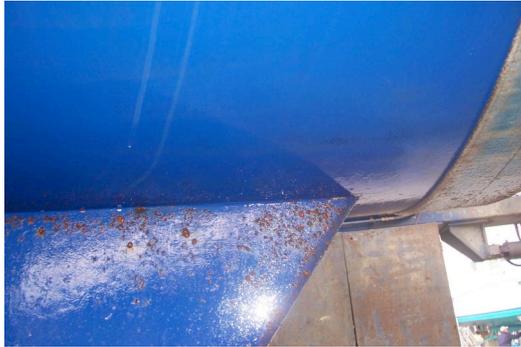
The surface of the keel is in fair condition with some rust spots beginning to bleed through (shown). This is not significant at present although it is likely the keel will have to be cleaned back to bare metal and re-finished within the next five years.

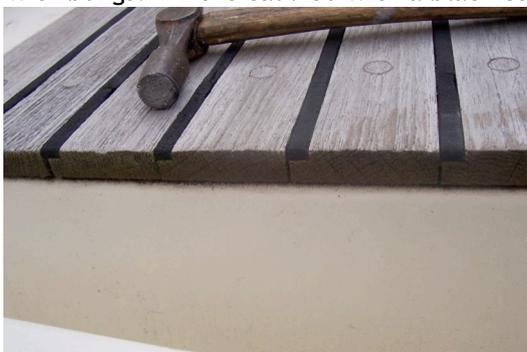
The seating above this and to starboard has a teak decking, secured by screws covered with bungs. This is caulked with a black compound which is cracked and loose in places (shown). As part of the long-term maintenance it should be removed and replaced with 'Sikaflex 290'. Instructions on how to use this and similar products are at <http://www.bluemoment.com/downloads/sikaflexmarinehandbook.pdf>

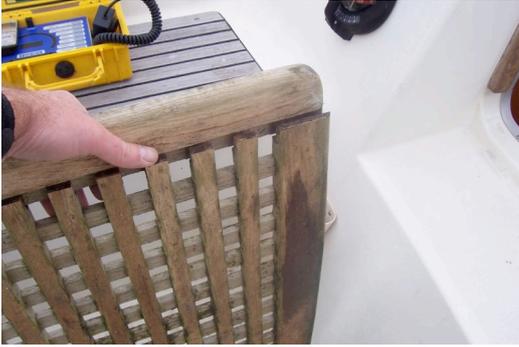
The cockpit sole has a teak grating which is in poor condition (shown). It is recommended that this be taken apart and re-glued with 'Balcotan' marine adhesive.

All teak surfaces (gratings, seating and hand rails) would benefit from teak restorer and oiling after any repairs are done but before planked areas are recaulked. Garden furniture restorer is sufficient for this but care should be taken to not allow it to drip on the gelcoat.

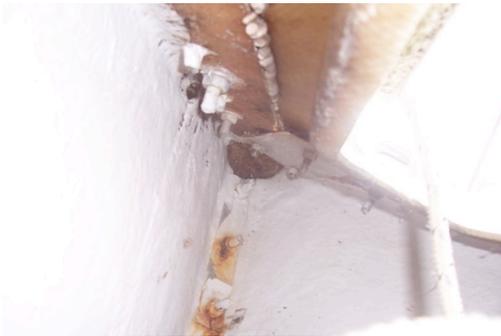
The hull has an inboard flange to which the deck moulding is secured by bonding paste and aluminium pop rivets which also secure the toe rail. The joint is over laminated on the inside across the transom where there is no toe rail. Where accessible within the anchor locker (shown) and stern compartment, the joint is in good condition with no signs of movement or leakage.

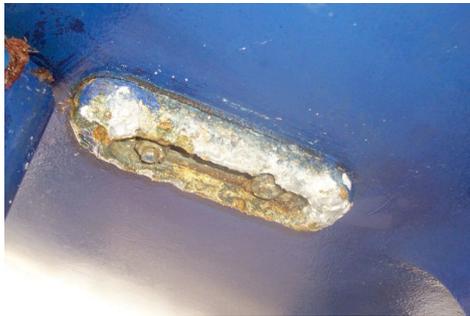
There is a zinc anode forward of the rudder (shown). This is about 20% eroded and in no need of immediate replacement. Its studs were lightly hammer sounded and found to be secure. The anode was tested with a continuity meter to the propeller and no significant resistance found (i.e. the internal bonding is in good condition).
