MARINE SURVEYOR

REPORT OF A CONDITION SURVEY CARRIED OUT ON THE VESSEL:

“ [REDACTED] ”

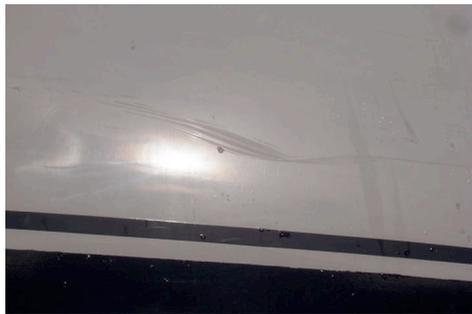
There is a deep chip to the gel coat at the stem about 0.5m above the boot top. This does not extend through to the gel coat and only needs repair for cosmetic reasons.

There are some minor scuffs and scratches on the port side around amidships (shown). These can be polished out.

There is a very slight manufacturing discontinuity where the sheer line and rubbing strake is slightly unfair on the starboard side midships (shown). There are no signs of this being the result of a major repair.

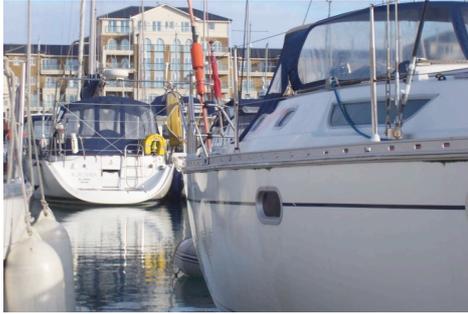
The starboard side is polished whereas the port side is relatively faded. This may simply be a result of how the vessel has been moored over the last year; wax polishing the whole will help maintain condition.

The aluminium rubbing strake combines with a toe rail and covers the hull to deck join. It has a white rubber insert which is in poor condition with several areas damaged by chafe or completely missing, both port and starboard. The aluminium is in good condition although it has mould growing beneath in several places. Apart from the visual appearance, it would be advisable to pressure wash this out to prevent 'poultice' corrosion.

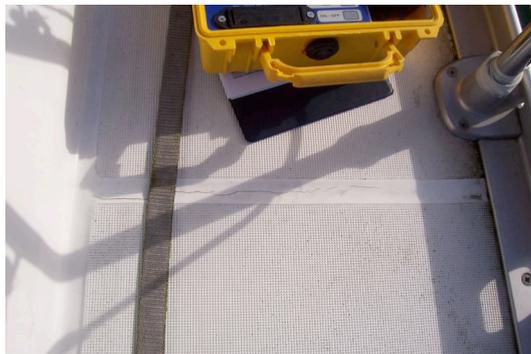
Around the port boarding gate there are two groups of transverse cracks across the side deck about 1.5m apart in clear sections of the gel coat (shown) (B). Both showed signs of movement when hammer sounded and small amounts of water could be forced out of the forward crack. Moisture meter readings were 90 about 10cm either side of the damage. This will (or may already) have caused the balsa core to rot which will reduce the strength and rigidity of the deck (it is firm at present). It is recommended

that the head lining be removed fore and aft of the bulkhead between chart table and aft

port cabin. The laminate on the underside of the sandwich deck construction should be removed 10-15cm either side of the cracks, taking care not to damage the upper laminate. An inspection of the exposed core will indicate whether this is sufficient, the object being to cut back to firm material. The core should then be replaced (it may be easier to source polypropylene core material), securing this with epoxy paste. The laminate on the underside should be remade with epoxy resin and cloth, laid up on a waxed piece of formica or similar and then propped or temporarily secured with self tapping screws and removed when set. This need not be particularly neat given it will be covered. The main thing is to overlap the damaged area by about 10cm so as to return strength to the structure. The deck cracks should then be filled with gel coat paste. The object of repairing from beneath is to avoid having to match deck gel coat colours and non slip patterns. I have found <http://www.cfsnet.co.uk> a good source of mail order supplies.

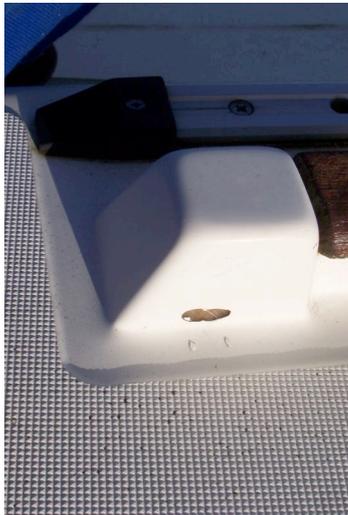
There are deep gel coat chips starboard forward and to the forward end of the starboard handrail mount (shown) **which should be filled (B).**
