MARINE SURVEYOR

REPORT OF A CONDITION SURVEY CARRIED OUT ON THE VESSEL:

‘ [REDACTED] ’

██████ is a Larson 274 single petrol engine performance motor cruiser built in 2006. There are few signs of wear or damage to her systems and structure and 101 hours on the engine counter.

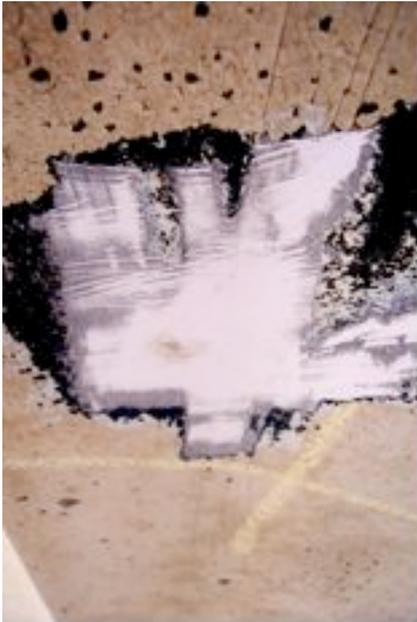
Two areas of impact damage were found on the bottom, the first on the starboard side 1m aft of the bow between the first and second spray rails and the second to port midships between the flat keel section and first spray rail. Both have longitudinal cracks in the antifouling which, when removed and examined under magnification, extends into the gelcoat as hairline cracks (shown below). These areas were pressed hard with a hammer handle and no movement seen in the gel coat cracks. Moisture meter readings were 14 deep and 17 shallow which is low and comparable with other areas on the laminate. **Taking all this into account, it is thought unlikely that these areas need attention beyond scraping old antifouling off, renewing the primer and then antifouling the entire hull (B).**

1. Scrape all loose antifouling off, renewing the grey epoxy primer where needed, particularly over the two areas with hairline surface cracks and then recoat the underwater hull with a suitable freshwater antifouling (B).

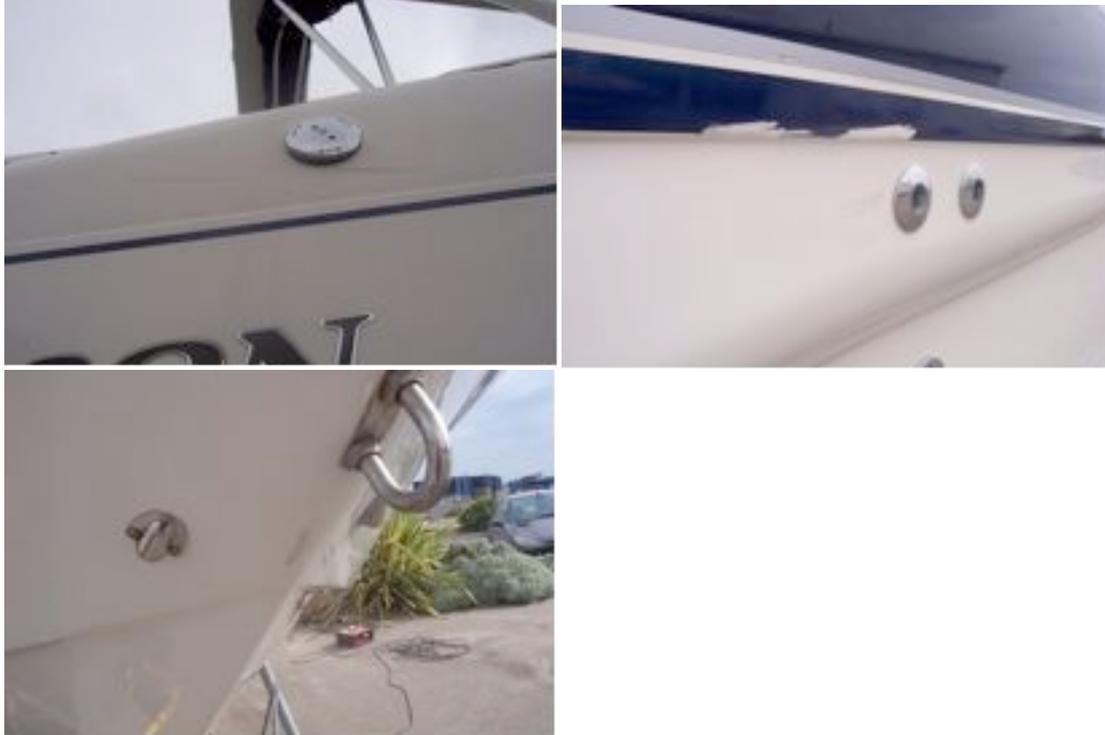
All areas were closely inspected for damage. A scrape mark is on the stem below the trailer eye (shown overleaf). This is too deep to polish out and will need filling if it is desired to restore cosmetic appearance.

There has been one or more impacts on the starboard side causing scuff marks, the removal of some of the vinyl tape (shown) and two deep scratches below the fuel filler. **Scuffs can be polished out but, as with the stem, the scratches will require filling with matched gel coat before they can be polished out. Adhesive stripes should be replaced (B)**

2. Replace adhesive stripes where required, polish out scuffs marks and fill and polish out deep scratches to the stem and below the fuel cap. (B)
3. Remove the starboard trim tab, clean crevice corrosion from under its base and re-fit with new stainless bolts (B).

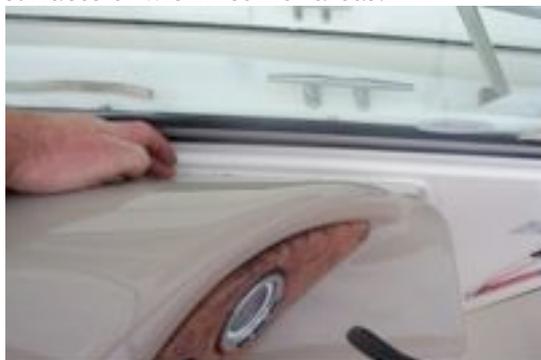
A gap was noted in the sealant securing the edge of the helm consol (the brown moulding shown in the photo) to the deck. **This sealant needs to be removed and replaced otherwise the gap will channel**

water into the cabling beneath (B)

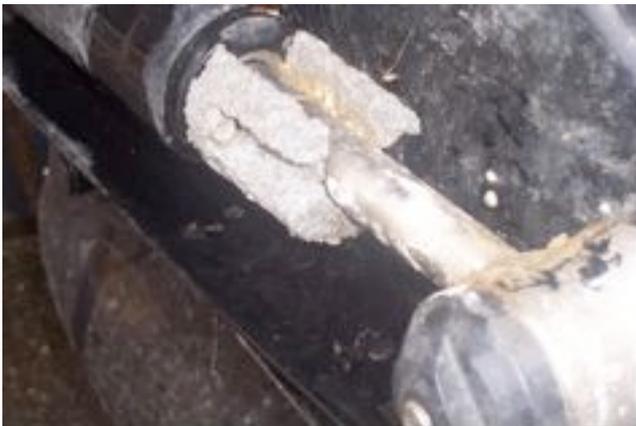
There are twin trim tabs which were tested ashore and during the sea trial and seen working. There are some signs of crevice corrosion beneath the starboard trim tab and around the heads of its six stainless steel securing bolts (shown).

It is recommended this trim tab is removed, corrosion under the base cleaned, resealed and fitted with new bolts (B).

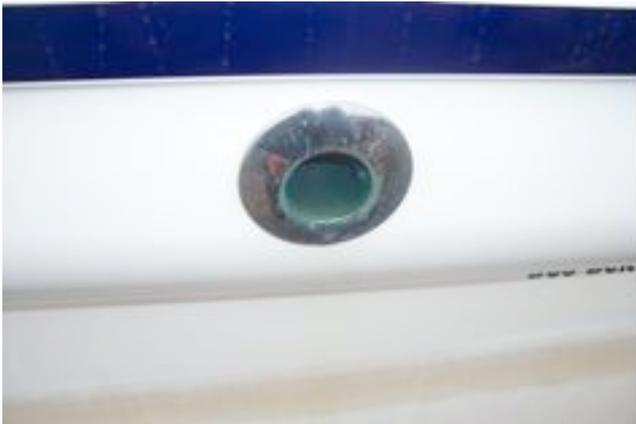
Above the waterline skin fittings appear to be chromed brass. All are secure but all show minor signs of cosmetic corrosion (toilet outlet shown as example).

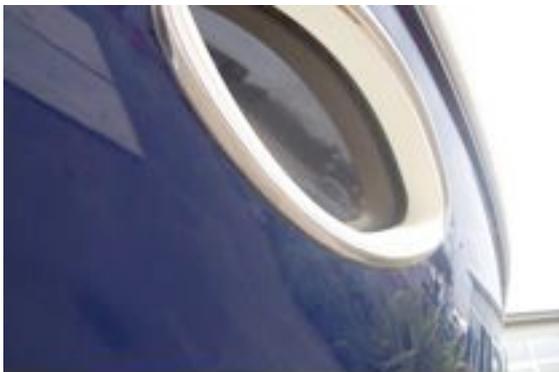
There are some minor signs of corrosion outside at the base of the forward light on the port side (shown) and it would be advisable to ensure the joint is thoroughly coated when the boat is wax polished to

prevent damage to the seals.

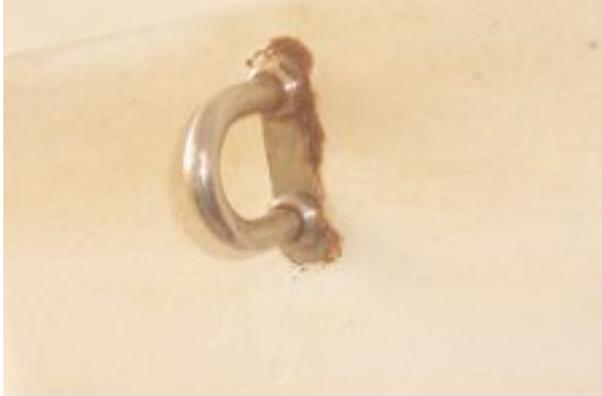
There are two similar bolts at the stern beneath the bathing platform. **The one to port (shown) has crevice corrosion at its base and should be removed and cleaned or replaced (B).**
