**MARINE SURVEYOR**

**REPORT OF A CONDITION SURVEY CARRIED OUT ON THE VESSEL:**

“ [REDACTED] ”

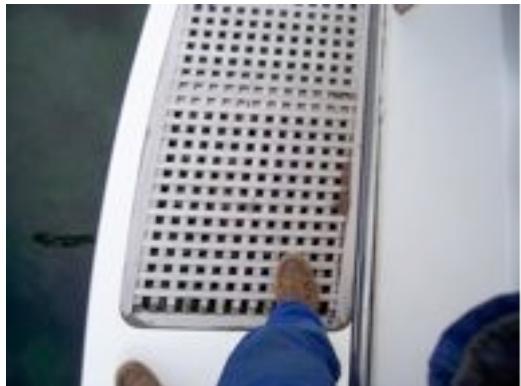
A bathing platform is fitted to the stern of the vessel (shown previous page). There is some corrosion to the fixing bolts although the structure is firm at present. The platform has teak grating which is broken on the starboard side and unable to bear weight. **This needs to be fixed temporarily or permanently because the damage is not evident and it would be possible to fall through the grate in its present condition (A).** A joinery workshop should be able to reconstruct the existing grate; the teak is mostly in good condition but the glue has failed.

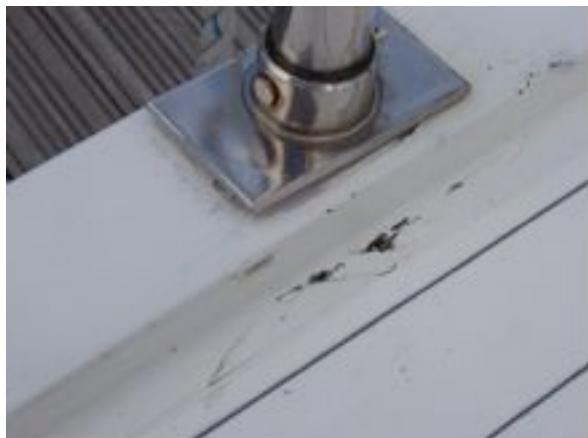
The first stanchion on the starboard side has suffered an impact damage which has caused the surrounding gelcoat to crack as shown. Moisture meter readings show that water has permeated into the underlying laminate and core of the deck sandwich.

**This needs to be addressed to prevent further deterioration by removing and re-bedding the stanchion and filling the cracked area (B).**

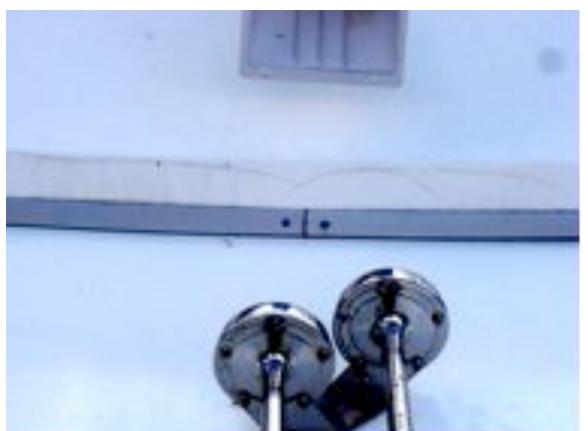
The flying bridge consol is a separate moulding bolted to the coachroof. This is of thinner construction and has crazing along the forward edge (shown). Moisture meter readings were around 20 in this area which shows there has only been limited ingress of moisture into the laminate. The dirt in the crazing can be removed with detergent followed by wax polish.

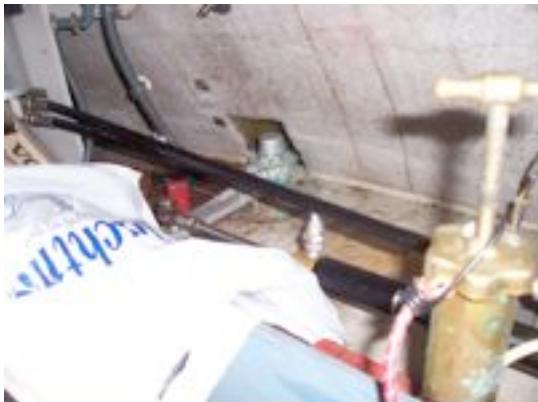
The port tiller appears to have been recently replaced or refurbished. **The starboard tiller shows signs of corrosion around its head (shown above) and should be cleaned and greased (B).**

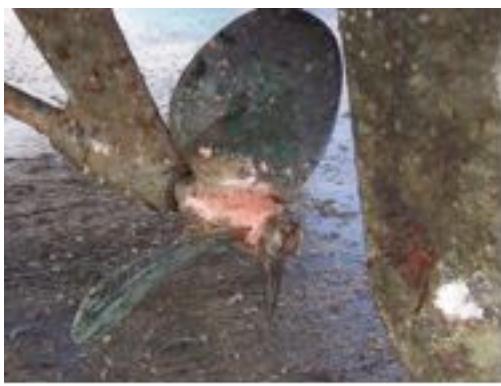
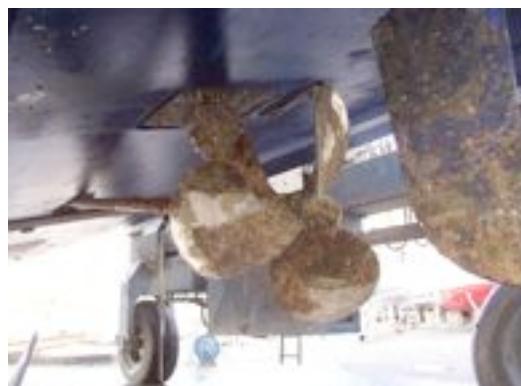
The vessel has contra-rotating propellers, 23" diameter x 27" pitch, believed to be 'Aquapoise' types. **The port propeller (left below) has de-zincified to the point it needs replacing - it has severe surface corrosion and will now be unbalanced (A) . The starboard**

propeller was inspected closely with a magnifying glass after removing oxidation from the blades. No signs of visible defect could be found, but in the absence of any anodes (see section E3 below), it will also rapidly de-zincify to the point that it needs replacement.

Both propellers were hammer sounded and found firm on their shaft tapers. Both are secured with crown nut and split pin. **Given the corrosion already found, it would be advisable to replace these items on both propellers (A).**

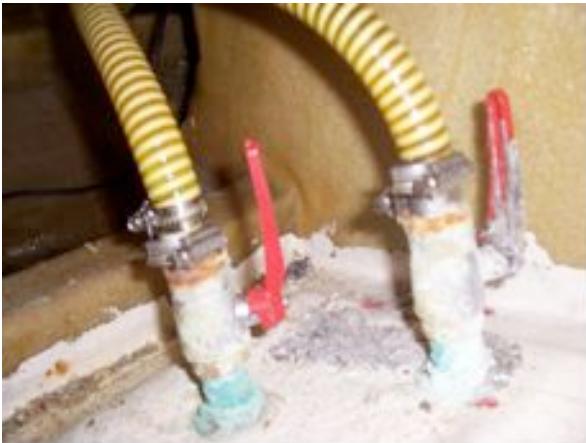
i. There are two bronze seawater inlets to starboard serving the forward heads compartments. The inboard valves for these are corroded and the handles extremely stiff as a result of leakage (shown). It is recommended they be removed and overhauled when the vessel is next ashore (B).

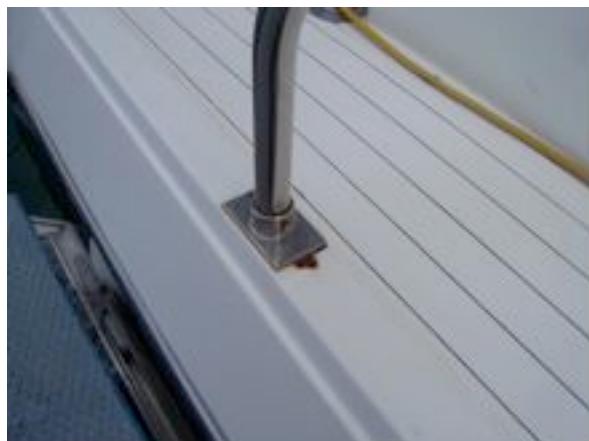
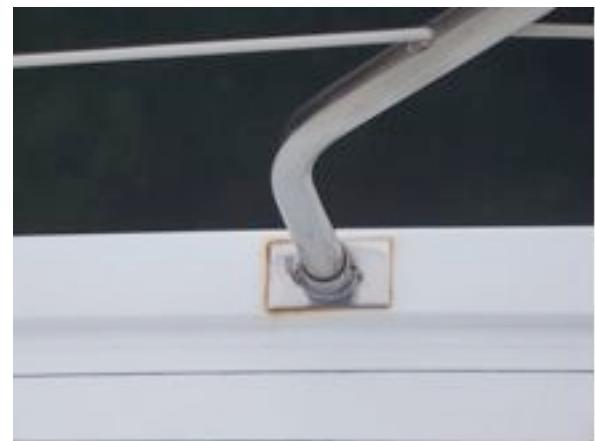
There are six stainless steel stanchions with a welded top rail and plastic covered stainless wire lower rail. The wire has chafed through its coating and shows signs of corrosion on the port side. It will need replacing in due course. Two of the stanchions (starboard aft and first forward port) have crevice corrosion at their base (shown). These should be removed, cleaned and re-bedded to prevent further corrosion.

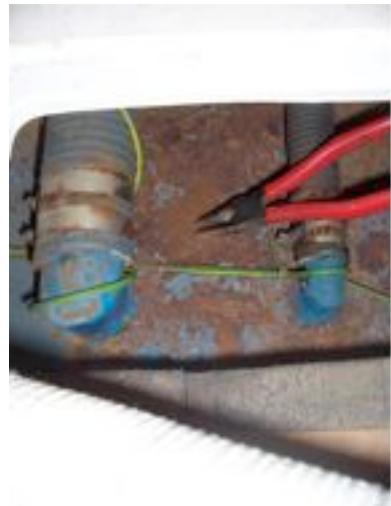
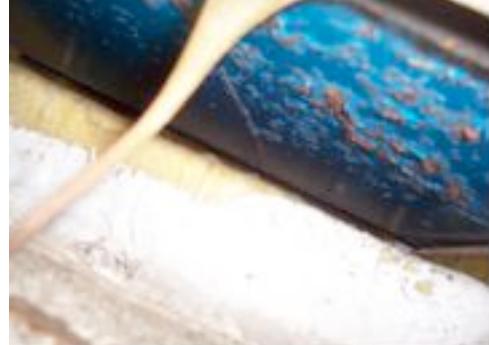
There are two 786lt mild steel fuel tanks strapped to wood bearers outboard of each engine. It was only possible to carry out a limited inspection of the top of both tanks using access hatches beneath the wheelhouse settees and a very limited inspection of their base using a digital camera and mirror in the engine space. The inboard sides and ends could not be inspected owing to glued sound insulation. The outboard sides are tight to the hull.

This showed that both tanks were badly corroded on their top surfaces where visible, with rust flaking off as a result of light scraping as shown. On those parts of the sides and base that were visible, surface rust could be seen (photo below). The inboard corner welds appeared relatively sound (photo below). There was no obvious

signs of fuel leakage from either tank.

The use of mild steel fuel tanks is a design fault with all Princess yachts and I have seen situations where the tanks had to be condemned due to rusting on the corner welds. This was not evident in this case. Note replacing the tanks is a major repair which involves removing both engines. I contacted the builders for advice, including possible spray coatings which might be applied in situ, the thickness of the tanks and any information on typical longevity. They replied with a copy of the manufacturers drawings (annexed) which appear to show the tanks are 3mm steel. Consequently you should take into account the risk of having to replace these tanks in the near future. It is possible to have the tanks pressure tested but, beyond advancing any incipient failure, this will not tell you anything about their potential lifespan. **You might also consider removing accessible flake rust and spraying as much of the tanks as possible with a rust converter product suitable for marine use such as 'Vactan' or 'Navy Steel' (B).**
