MARINE SURVEYOR

NAME OF VESSEL : **CLASSIC TEAK SLOOP**
REFERENCE : **XXXX**

The survey was carried out as an insurance survey to establish the general condition of the vessel and its value. It contains fewer details and information than a full survey and should not be relied on by a prospective purchaser. References to condition are in relation to the vessel's age (i.e. good condition does not necessarily mean new).

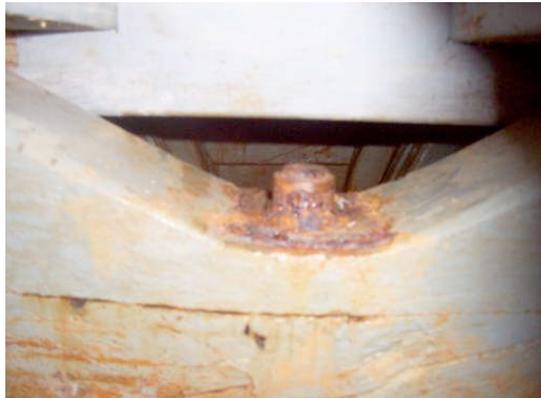
Where access could be gained, the keel bolts were hammer sounded and the nuts tested for tightness. The fifth (aftermost) bolt was tight and in satisfactory condition. The fourth bolt was in reasonable condition. The nut on the third bolt is in poor condition. This appears to be a non marine grade stainless steel 'Nyloc' nut which has corroded as shown. A limited inspection of the second bolt (using a mirror) showed it to be good quality nut in reasonable condition but it was not possible to hammer test it or apply a spanner for the reasons mentioned in the above paragraph. No access could be gained to the first bolt.

It is recommended that the nut on the third keel bolt be replaced, bedding this down on a new metal plate washer, about 5 x 5 cm size (B).

Given the lack of any signs of movement within the keel and backbone structure at present, it is considered sufficient to carry out this work within the next year. However if extended offshore cruising is planned, it is recommended that all the keel bolts be removed for inspection and replacement as necessary.

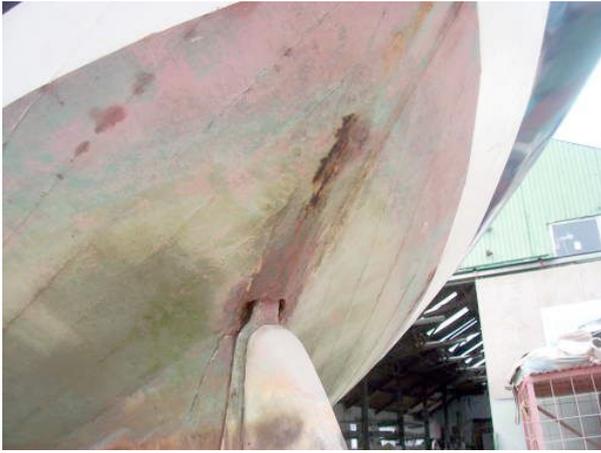
There are signs of deterioration to the fastenings which secure the horn timber to the frames as shown. This structure was hammer tested and no signs of movement noted, or any weakness in the surrounding structure. *However given the signs of corrosion, it is recommended these fastenings be drawn for inspection and replaced as necessary within the next year (B).*

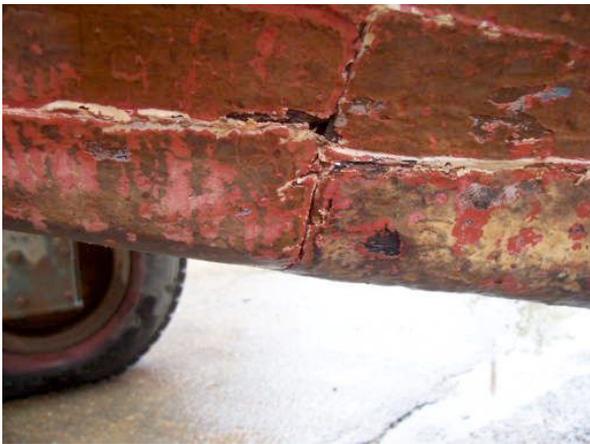
The stem is constructed of a substantial inner, elm, timber running from the keelson to the fore foot. The garboard and hood ends attach to this. The stem capping piece is made up of several shorter sections, through fastened to the inner stem. These timbers have become saturated and softened where they are butt jointed as shown. *Although sufficient strength remains at present, it is recommended that when the vessel is next hauled out, the coatings are stripped from this area and the wood allowed to thoroughly dry. Any remaining soft patches should be removed and filled with thickened epoxy (B).*

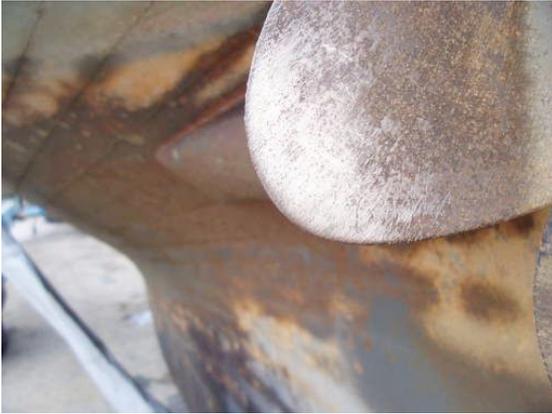
The outboard propeller shaft bearing is loose, one of its two bronze securing screws being broken off at the head and the other slack. This may explain the leak mentioned in section D2. *It is recommended that the bearing be refitted, with a suitable oil based mastic used to fill any gap between the shaft*

The propeller is loose on its shaft. On inspection it was found that the shaft nut was tightened to the limit of the threaded section at the end of the shaft leaving a 5 mm gap between the nut and the propeller boss. There is no sign that the angle of the shaft taper is mismatched, although it may be that the new propeller taper (fitted last year) was drilled to a slightly larger diameter than the original propeller, or that the original had a longer boss. *It is recommended that a washer or washers be fitted between the propeller and its securing nut to make good the gap. This should have an exterior diameter of 35 mm, interior diameter of 20 mm and be 5.5 mm thick (A).*

tube and shaft log (A). The existing broken fastening needs to be removed and the hole plugged and re-drilled so that the bearing can be reinstalled in the same position to allow the water scoops to align with the existing cutouts in the shaft log. If this is not possible, it may be possible to plug the existing holes and turn the bearing through about 5° on the shaft so that new pilot holes can be drilled without blocking the water scoops. The bearing should be well bedded in a suitable mastic and secured with bronze coach bolts, care being taken to avoid misaligning the shaft.

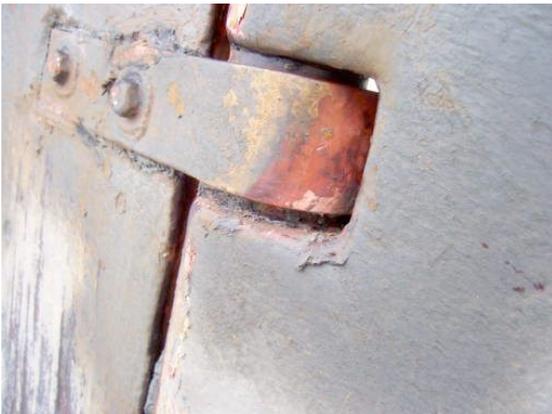
There is no cathodic protection system and it is recommended that one be installed given signs of early pitting noticed on the propeller and the erosion of the bronze rudder strap as shown in the photos.

It is recommended that a button anode be fitted to one of the existing bolts that secure the upper rubber strap. It is further recommended that either a 1" shaft anode be fitted (this will need to be no more than 30 mm length in order to allow sufficient play and flow of water through the stern bearing) or that a through hull

anode be fitted on the vessel's port side and connected to the shaft via the engine, using bridging wires across the flexible shaft coupling.

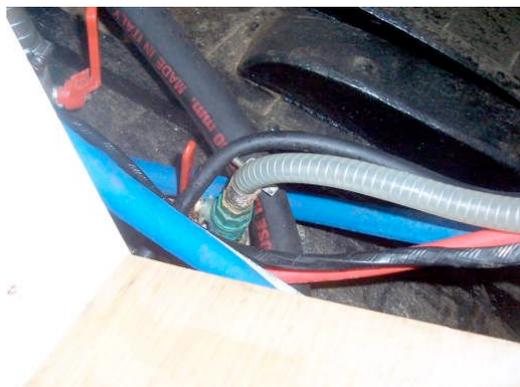
The engine cooling water intake skin fitting and seacock are new and in good condition but show early signs of corrosion due to seepage from the hose attachment. *It is recommended that the existing plated steel hose clip, which appears corroded, be replaced with two stainless steel clips (B).*

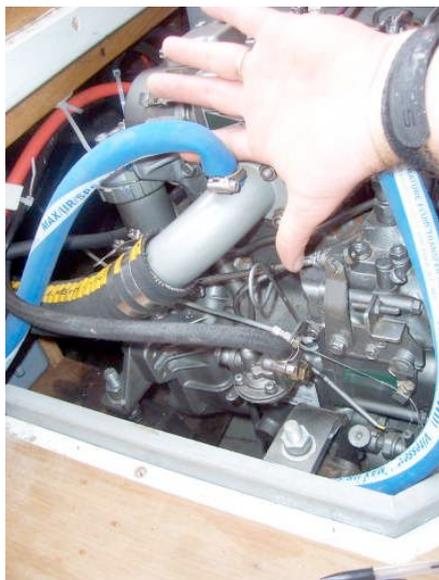
The cooling water supply hose to the exhaust injection bend is kinked where it turns too tight a radius, as shown. This will worsen when the engine becomes hot. *It is recommended that the hose be given additional support either by securing it with a large cable tie to a screw eye in the bulkhead above or by fitting plastic reinforcing to the curve such as used on domestic washing machine outflows (B).*
