MARINE SURVEYOR

REPORT OF A CONDITION SURVEY CARRIED OUT ON THE VESSEL:

Beneteau Oceanis 473

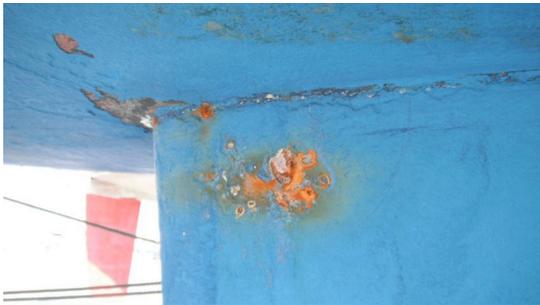
There is a rust bleed through at the forward part of the keel (shown) which will need to be ground back to bare metal and re-primed when the boat is next ashore (B).

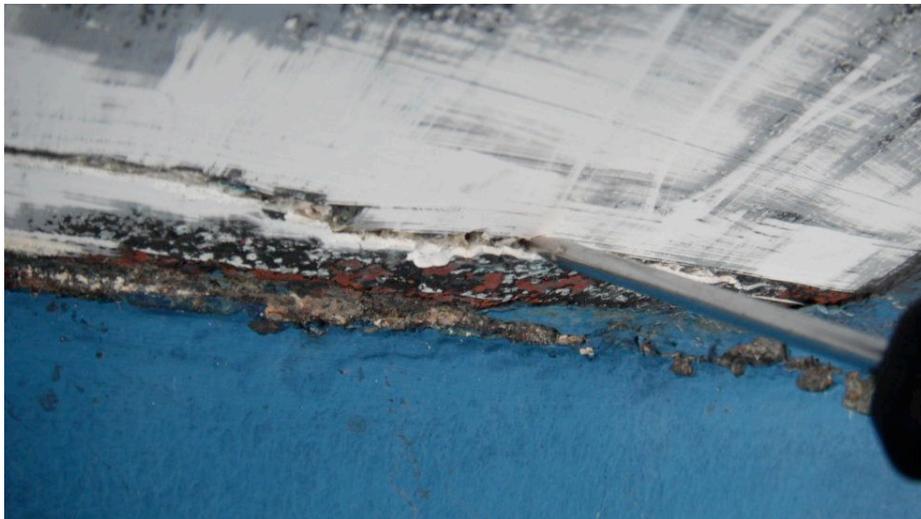
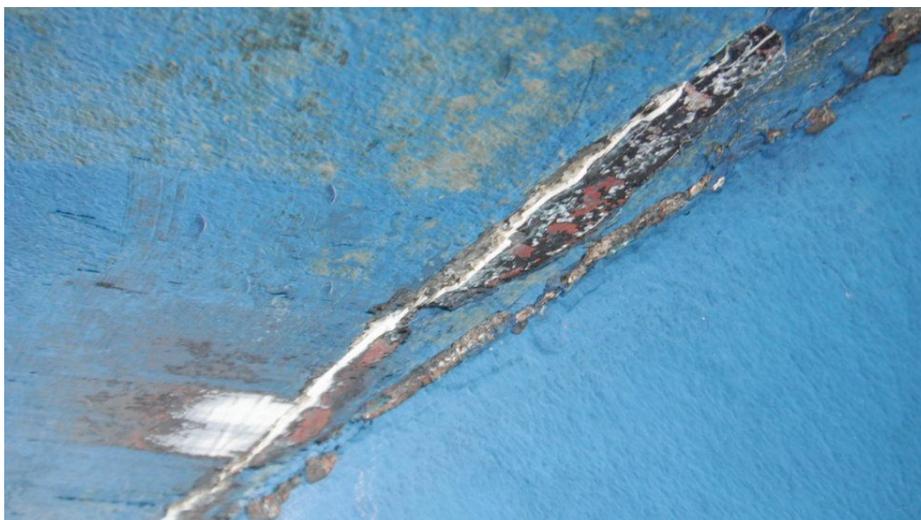
Three faults were apparent; damage to the rudder base which had recently been repaired, damage to the top of the rudder and a crack penetrating through the gel coat on the port side of the keel at its widest point. This is about 25cm long and 1cm out, parallel to the centreline.

The crack has displaced the surface down by about 1.5mm alongside the keel and the gelcoat is still attached to the laminate. This is significant because it means there is likely to be internal damage to the laminate in an area which would be highly stressed when the vessel heels in strong winds.

Although it is impossible to be certain, it is unlikely the damage occurred as a result of heavy weather or a manufacturing defect; the boats have a good reputation for build quality and I have never heard of similar damage on others of this class.

The most likely explanation follows on from the owners description of how the base of the rudder was damaged by it striking the edge of the hauling out area when the vessel was last lifted ashore by travel hoist. This may also have damaged the top of the rudder (see section E1), as it moved up within its bearing and hit the hull. That would have caused the entire boat to tilt forward, striking the keel and forcing it sideways. The fracture is at the widest point of the ballast keel where the leverage would be greatest. The matter should be take up with the boatyard who presumably have already admitted liability for the damage to the base of the rudder (which was seen repaired).

Whilst it should be possible to use the boat safely in moderate conditions, it would not be safe to use the boat where she could be exposed to heavy weather such as the proposed delivery passage from Valencia to Brighton.

Repair would involve grinding back the damaged area and inspecting the laminate beneath. If there is any sign of internal separation where the hull is bonded to the keel this will have to be removed, all loose material removed and re-laminated. The internal moulding would need to be similarly ground back and re-laminated where it is cracked (A).

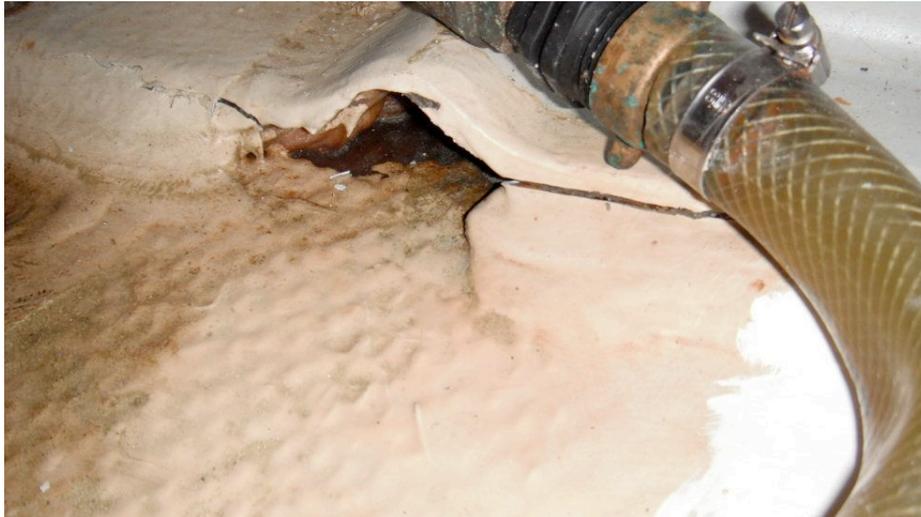
Inside the boat the internal moulding is cracked in the same area (example shown) and new flow coat has been applied.

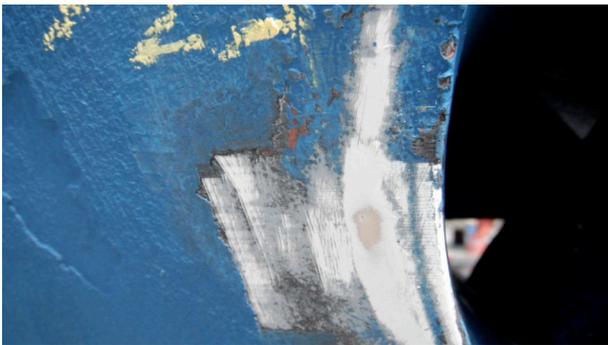
The bow thruster tube was inspected and lightly hammer sounded both inside the hull and out and found to be securely laminated into the structure. An area of thin gelcoat was found forward of the bow thruster to port (shown).
