Aidan Tuckett B.Sc.(Hons).

MARINE SURVEYOR

REPORT OF AN INSURANCE SURVEY CARRIED OUT ON THE VESSEL:

██████████ 1982 wooden sloop

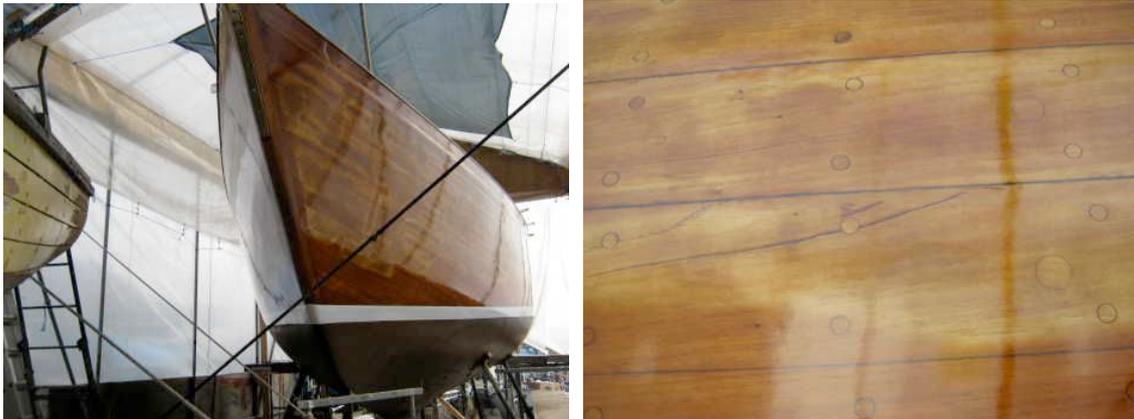
D4. Topsides planking, bulwarks etc.

The topsides are carvel laid varnished Brazilian cedar, for the most part tight seamed with some thin splines of the same wood or hard stopping in places. As with the underwater hull, the planks are screwed to the frames and the screws bunged with the same wood. No loose or missing bungs were seen. The surface finish is very good having been recently refurbished (shown). There is some variation in colour but to remove this would entail sanding thickness out of the planking which is not advisable.

The planks are clear grained, single lengths with no significant splits, darkening or other signs of deterioration beneath the varnish. The hood ends are tight with no signs of movement. The curves are fair with no deformation along the run of the planks or 'stepped' appearance across the seams.
