MARINE SURVEYOR

REPORT OF A CONDITION SURVEY CARRIED OUT ON THE VESSEL:

‘ [REDACTED] ’

██████ is a Larson 274 single petrol engine performance motor cruiser built in 2006. There are few signs of wear or damage to her systems and structure and 101 hours on the engine counter.

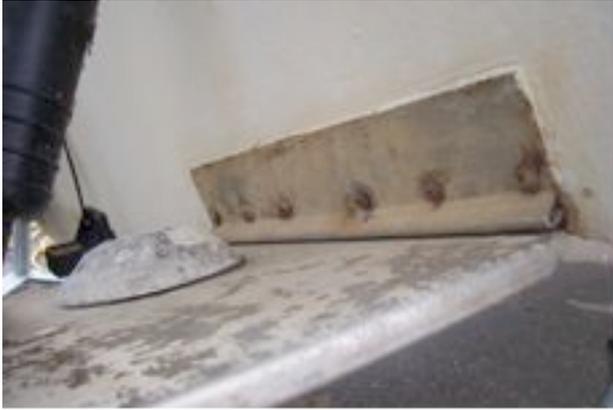
There are twin trim tabs which were tested ashore and during the sea trial and seen working. There are some signs of crevice corrosion beneath the starboard trim tab and around the heads of its six stainless steel securing bolts (shown).

2. Replace adhesive stripes where required, polish out scuffs marks and fill and polish out deep scratches to the stem and below the fuel cap. (B)
3. Remove the starboard trim tab, clean crevice corrosion from under its base and re-fit with new stainless bolts (B).

It is recommended this trim tab is removed, corrosion under the base cleaned, resealed and fitted with new bolts (B).

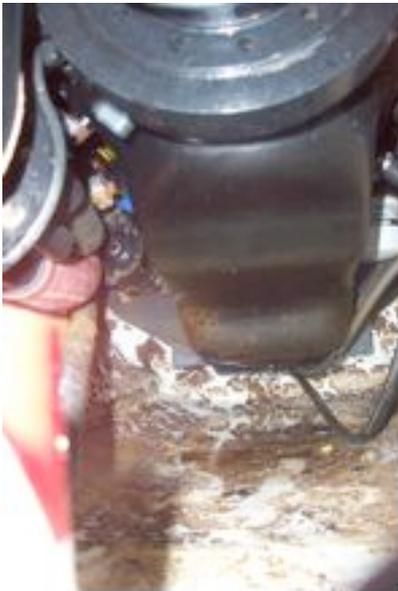
I1. Installation.

The engine is a Mercruiser 5.7 TKS 250hp V8 petrol inboard. Although 102 hours is shown on the dashboard hour counter, it is believed that the engine has been replaced. From external appearance, it has had very little use and is in virtually new condition.

The installation is well laid out with good access from the lifting cockpit floor hatch. A screw down panel aft of this can also be removed.

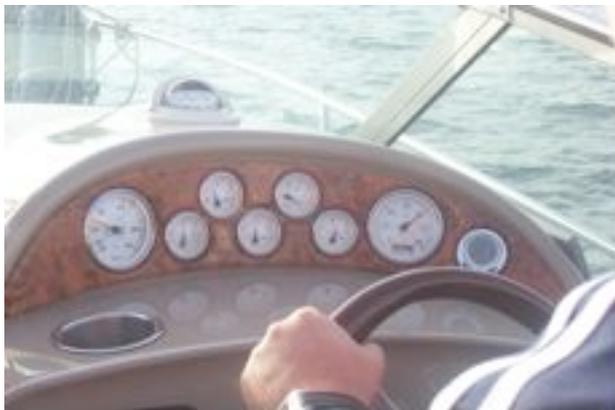
A kill cord is attached to the base of the single lever control. This is in working order.
