**MARINE SURVEYOR**

**REPORT OF A CONDITION SURVEY CARRIED OUT ON THE VESSEL:**

“ [REDACTED] ”

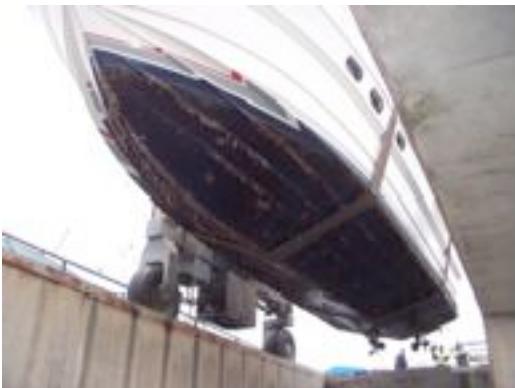
The vessel was lifted and hosed off for one hour on 29 October and the underwater hull visually inspected. The condition of the anodes and stern gear are covered in section E.

has not been used or antifouled for some time. **The existing antifouling has some build up, is adhering poorly and in need of replacement (B).** Further cleaning will be needed before the hull can be painted.

The underwater hull is a medium to deep V design with three spray rails parallel to the chine. The underwater area was hammer sounded and visually inspected. No visible signs of osmotic blistering or delamination were found. The chines and spray rails were gently hammer sounded and no voids found. There were no visible signs of impact damage or past repairs to the chines, forefoot or other vulnerable areas. There was no deflection along the line of the keel where the vessel was held by the lifting struts.

Limited moisture meter readings were taken over the underwater hull and found to range between 10-30 shallow and 15-50 deep. Taking the lack of drying time into account, these indicate that no significant ingress of moisture into the laminate has occurred where tested.

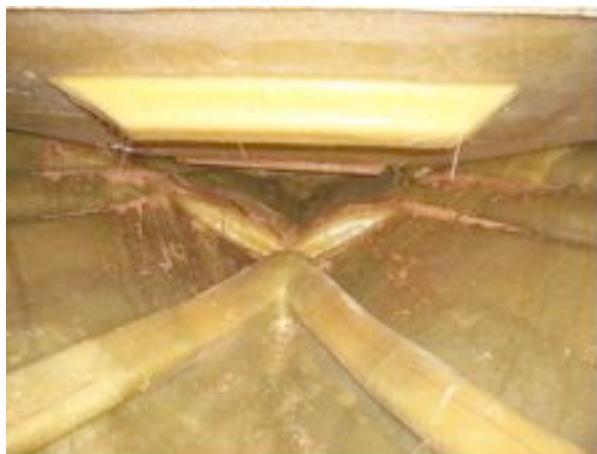
There are three deck to keel bulkheads; aft of the two heads compartments and at the fore and after end of the engine compartment. All are cored fiberglass with oak plywood facing in the accommodation areas.

These were inspected and hammer sounded where accessible and found to be well bonded and secure. Half bulkheads which support the cabin sole are at approx 0.7m intervals, again these were found secure where accessible.

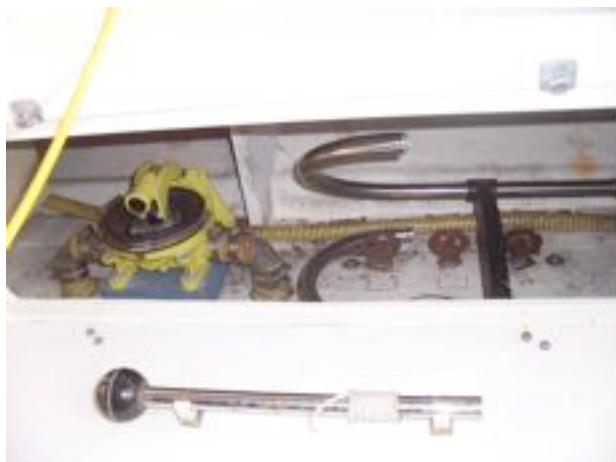
The vessel is divided into three bilge compartments; the forward cabin, the engine space, and the stern compartment. Each has its own electric bilge pump and float switch. The pumps can also be directly controlled from the helm position. All three pumps were tested and found in working order.

A Whale 'Gusher 10' manual bilge pump is fitted in the starboard cockpit locker (shown). The pump was tested and appeared in working order.

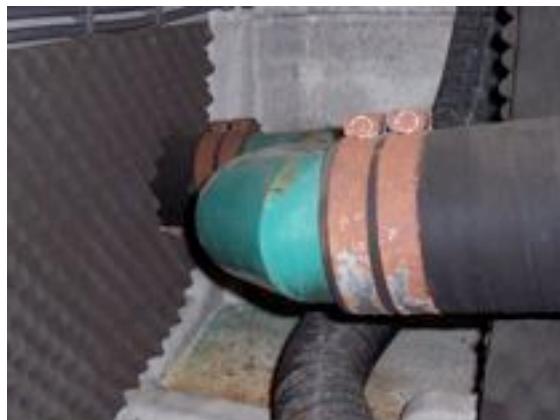
At the end of the sea trial when manouevring at low revs, the port engine warning indicators for temperature and oil flickered on and off.

Taking all the above into account, the engines appear in good working order at this time but are in need of a full service (B).

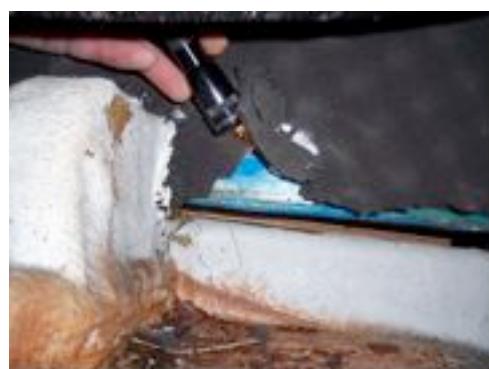
The fuel system has fixed copper piping from the tanks to paired water separators via three shut off cocks operated from the port cockpit locker (port and starboard main engines plus generator) These operate smoothly. The separators are securely mounted on the aft engine bulkhead and appear clean with no build up of dirt or water. The line then runs to the

engine with copper and flexible piping. The latter is marked to the correct ISO 7840 standard and is in good condition.
