MARINE SURVEYOR

NAME OF VESSEL : **CLASSIC TEAK SLOOP**
REFERENCE : **XXXX**

The survey was carried out as an insurance survey to establish the general condition of the vessel and its value. It contains fewer details and information than a full survey and should not be relied on by a prospective purchaser. References to condition are in relation to the vessel's age (i.e. good condition does not necessarily mean new).

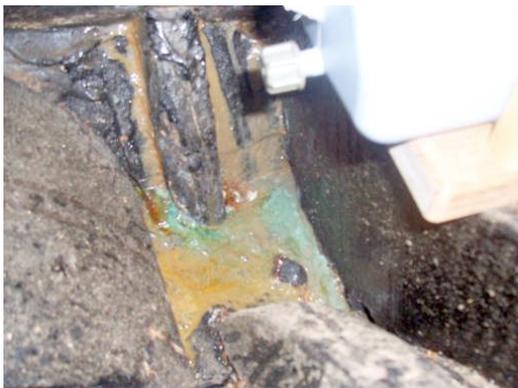
A leak was noted from behind the engine when the vessel was afloat. This appears to come from the lower edge of the inner shaft log (the rectangular wooden block which supports the stern tube for the offset propeller, shown upper right). This further supported by the fact that one of the two securing bolts for the outboard shaft bearing has sheared (see Section E2 - sterngear). The flow can be seen as two brown lines either side of the frame which emerges from the shaft log.

5. *The nuts on the through bolts holding the inner shaft log need to be tightened (B).*
6. *The plated steel hose clip to the engine cooling water intake hose should be replaced with stainless steel clips (B).*

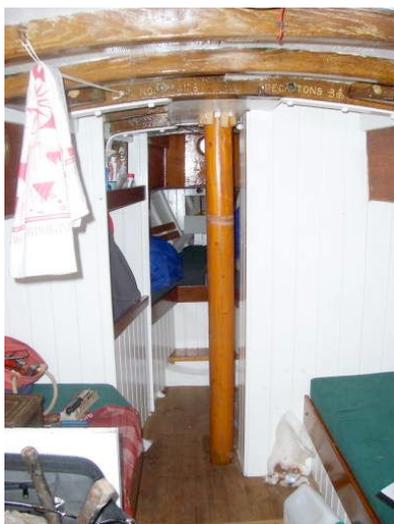
The accommodation joinery and upholstery is to a high standard. There are two berths amidships, a hanging space and sea toilet forward, and two further berths in the forepeak. Two symmetrical work surface areas are fitted either side of the main hatch. The entire structure is new.
